The real issues with in-ground SUDS in Scotland

W. Schlüter^{1*} and C. Jefferies²

The aim of this research was to produce enhanced detailing and improved operation of in-ground SUDS. Data from on-site monitoring at three filter drain and three infiltration trench systems were analysed and the results were combined with information gathered from 40 assessments of *in-situ* systems in Eastern Scotland. Current findings showed that almost 50% of all systems were found to be unsatisfactory and more than half of these were rated as having failed. 36% provided fair and 16%, good performance. Only one system was considered to be performing excellently. Several reasons were identified for the poor performance. The principal cause of problems was runoff from unstabilised areas or construction runoff, which was found to be affecting the systems' longevity. Almost 30% of all sites were affected by construction runoff. Another major problem was related to system maintenance since maintenance programs were generally not in place. This study has shown that regular maintenance is vital for the longevity of in-ground SUDS.

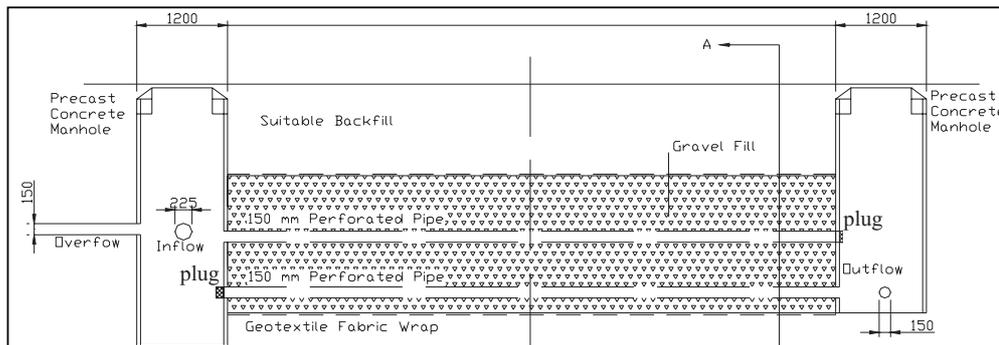
Figure 2: Infiltration trench at Broxden

Good detailing. Only one of the systems under investigation was found to be performing excellently and this is shown in Figure 2. The inlet pipe of the infiltration trench runs for the system's full length and this maximises the inflow capacity. This system is 43m long and 0.75m wide, the sump is 1.0m deep and the inlet and outlet pipes (of the inlet sump/ chamber) are level, promoting good debris settlement.

Crucial for the performance of the system at Broxden are the two plugs, cutting-off flow at either end of the drainpipes. They can be removed for inspection and to enable cleaning by high pressure jetting and flushing of drainpipes. However, there are a number of points, which could further improve the system at Broxden: Installing a dip plate in the inlet to retain floating debris; Raising the elevation of the outlet to utilise additional storage; raising the top perforated pipe to improve filtration; Increasing the elevation of the overflow to provide additional storage.

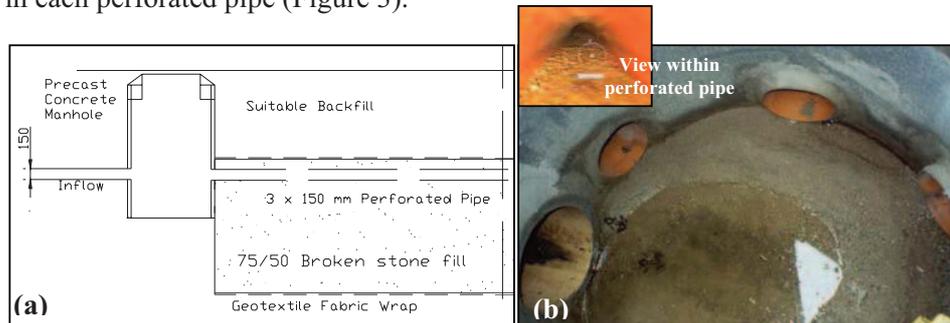
Figure 3. Shallow soakaway arrangement (a); sedimentation in chamber (b)

Good flow distribution. An alternative an end-pipe soakaway arrangement is illustrated in Figure 3. It is also located downstream from a conventionally drained suburban development (of around 24 houses). In this case there is a reasonable chance of longer-term good behaviour, firstly because there are three routes from the inlet manhole into the filter material, providing good flow distribution and giving a reduced pollutant load per length of pipe. The elevation of the pipe maximises the system's storage as it is located close to the top of the filter material. The site visit to this location provided unexpected findings as the inlet sump

of the system was filled with sediments and there was also a considerable amount of sediment in each perforated pipe (Figure 3).

Findings at this site show the typical impact of construction runoff and poor site management. Although both the design and construction of the system showed good practice, the system silted up quickly as it was connected to the surface drainage too early and sediment management was poor.

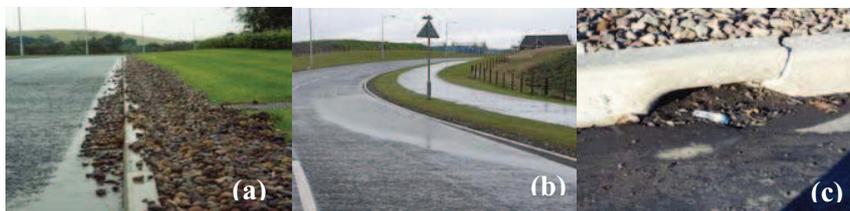
Figure 4: Problems with offset kerb arrangements along Spine Road

Problems with filter drains & lateral inlets. A further commonly used technique is the French drain installed in car parking areas and roadsides. These systems should improve water quality performance due to the filtering out of pollutants and this is promoted by disconnecting the drainpipe from runoff. However, a number of problems were discovered as follows:

- Filter material was distributed onto the road (see figure 4(a)).
- Blocked lateral inlets resulted in local flooding (see figure 4(b)).
- Broken lateral inlets at three locations (see figure 4(c)).

Offlet kerbs were found to be problematic as inlets to filter drains. This was mainly due to the inability to clean and maintain the inlets. Blocked inlets were found at both sites which incorporated offlet kerbs. Road safety was an issue at one site, where filter material had spilled onto the road

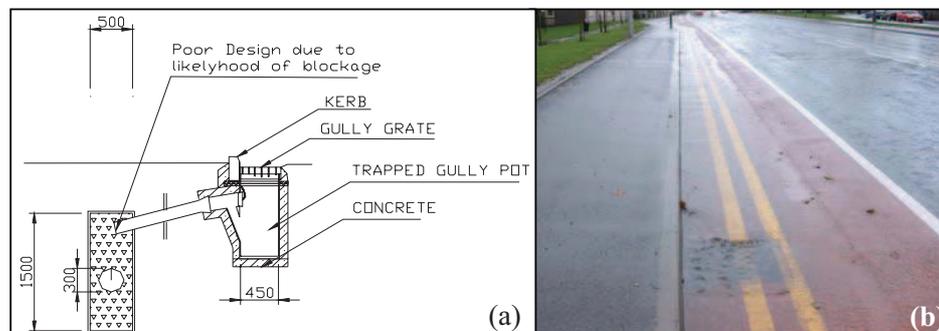
Figure 5: Road side filter drain arrangement (a); Flooding due to blocked gully outlets (b)

Insufficient flow capacity. The next example is a filter drain along a busy commuter route in an older urban area (known as Lang Stracht). The inlets to this system (shown in figure 5) comprise trapped gully pots which discharge directly into the filter media and these were found to have failed hydraulically due to blockage.

The flow capacity at this type of inlet is extremely low and small amounts of debris were found to have blocked the gully pot outlets. Figure 5 shows flooding of the system after an event of relatively small rainfall intensity of 13.2 mm/h.
